**Asbestos Containing Building  
Material Survey  
of  
Administration Building**

**Isabella County  
200 North Main Street  
Mt. Pleasant, Michigan 48858**

**Northern Analytical Services, LLC.  
PO Box 1604  
Big Rapids, Michigan 49307**

**Project No.: 230145  
Report Date: October 27, 2023**

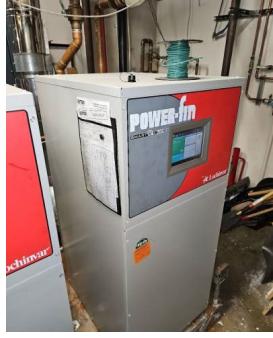
Asbestos Detected: No Asbestos Type: None Detected Percent Asbestos: ---	Asbestos Detected: Yes Asbestos Type: Assumed Percent Asbestos: ---
Material # 5	Material # 6
Boiler Material (inside) - Lochinvar Boiler	Spray on Fireproofing - Grey, Fluffy, Gold Flakes

Asbestos Detected: Yes Asbestos Type: Assumed Percent Asbestos: ---	Asbestos Detected: Yes Asbestos Type: Chrysotile Percent Asbestos: 5-10%

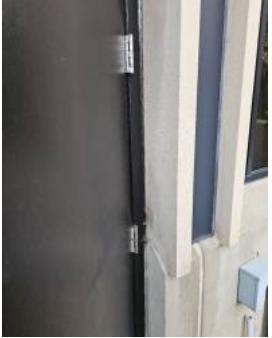
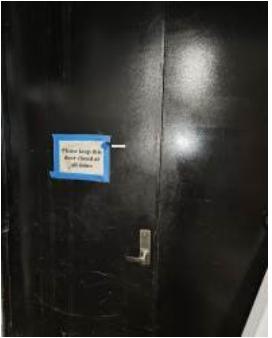
Material # 7	Material # 8
Caulk - On Exterior Steel Door Frame	Wood Door - Solid

Asbestos Detected: No Asbestos Type: None Detected Percent Asbestos: ---	Asbestos Detected: Yes Asbestos Type: Assumed Percent Asbestos: ---
Material # 9	Material # 10
Fire Rated Door -	Caulk - White On Interior Steel Door Frame

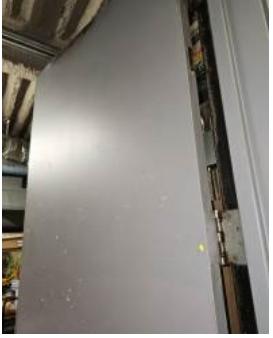
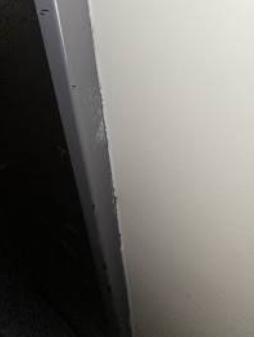
Asbestos Detected: Yes Asbestos Type: Assumed Percent Asbestos: ---	Asbestos Detected: No Asbestos Type: None Detected Percent Asbestos: ---
Material # 11	Material # 12
Flooring-Carpet Glue - Yellow	Flooring Layer Assumed Under Surface Layer -

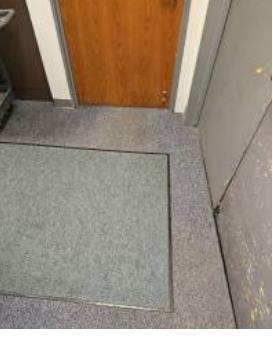
Asbestos Detected: No Asbestos Type: None Detected Percent Asbestos: ---	Asbestos Detected: Yes Asbestos Type: Assumed Percent Asbestos: ---

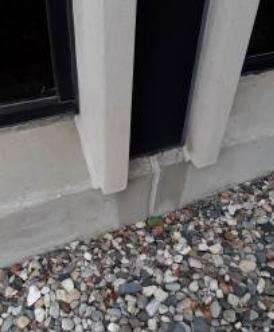
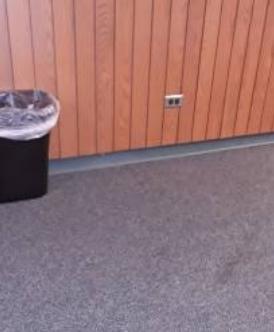
Material # 49	Material # 50
Caulk - Tan, Expansion Joint	Cove Base - 4in Green

Asbestos Detected: No Asbestos Type: --- Percent Asbestos: ---	Asbestos Detected: No Asbestos Type: None Detected Percent Asbestos: ---
Material # 51	Material # 52
Ceiling Tile - 1x2ft, Jigsaw Pattern	Miscellaneous - Skim Coat on Cement Walls

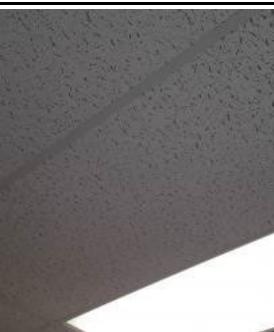
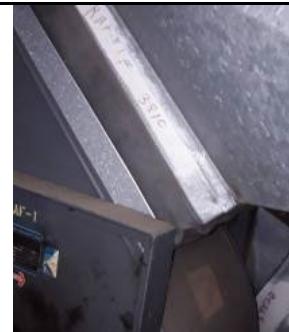
Asbestos Detected: No Asbestos Type: None Detected Percent Asbestos: ---	Asbestos Detected: Yes Asbestos Type: Assumed Percent Asbestos: ---
Material # 53	Material # 54
Ceiling Tile - 2x4ft Pinholes and Scratches	Vibration Dampener Cloth -

Asbestos Detected: No Asbestos Type: None Detected Percent Asbestos: ---	Asbestos Detected: No Asbestos Type: None Detected Percent Asbestos: ---

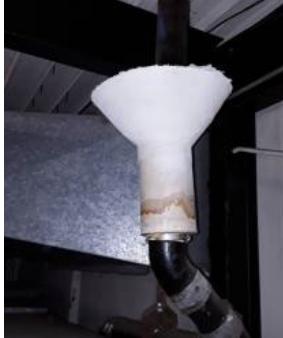
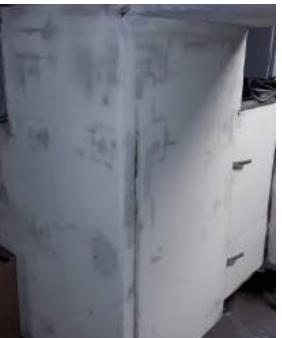
Material # 55	Material # 56
Pipe Insulation-Muddled Fitting - Roof Drain	Duct Work Insulation - Fiberglass

Asbestos Detected: No Asbestos Type: None Detected Percent Asbestos: ---	Asbestos Detected: No Asbestos Type: None Detected Percent Asbestos: ---
Material # 57	Material # 58
Caulk - On Exterior Louver, Grey	Miscellaneous - Concrete Siding/Soffit

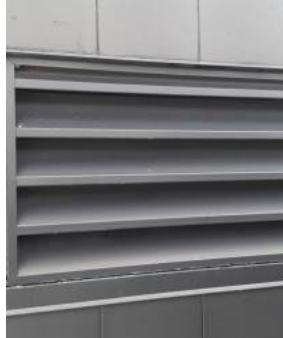
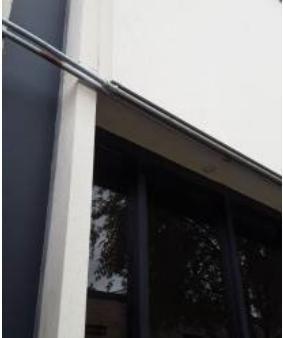
Asbestos Detected: Yes Asbestos Type: Chrysotile Percent Asbestos: <1%	Asbestos Detected: No Asbestos Type: None Detected Percent Asbestos: ---
Material # 59	
Roofing -
